The Nose Knows: Canine Scent Tracking

Canine Scent Tracking A Case Study

**Grand Traverse Bay Watershed
Healthy Beaches Program**

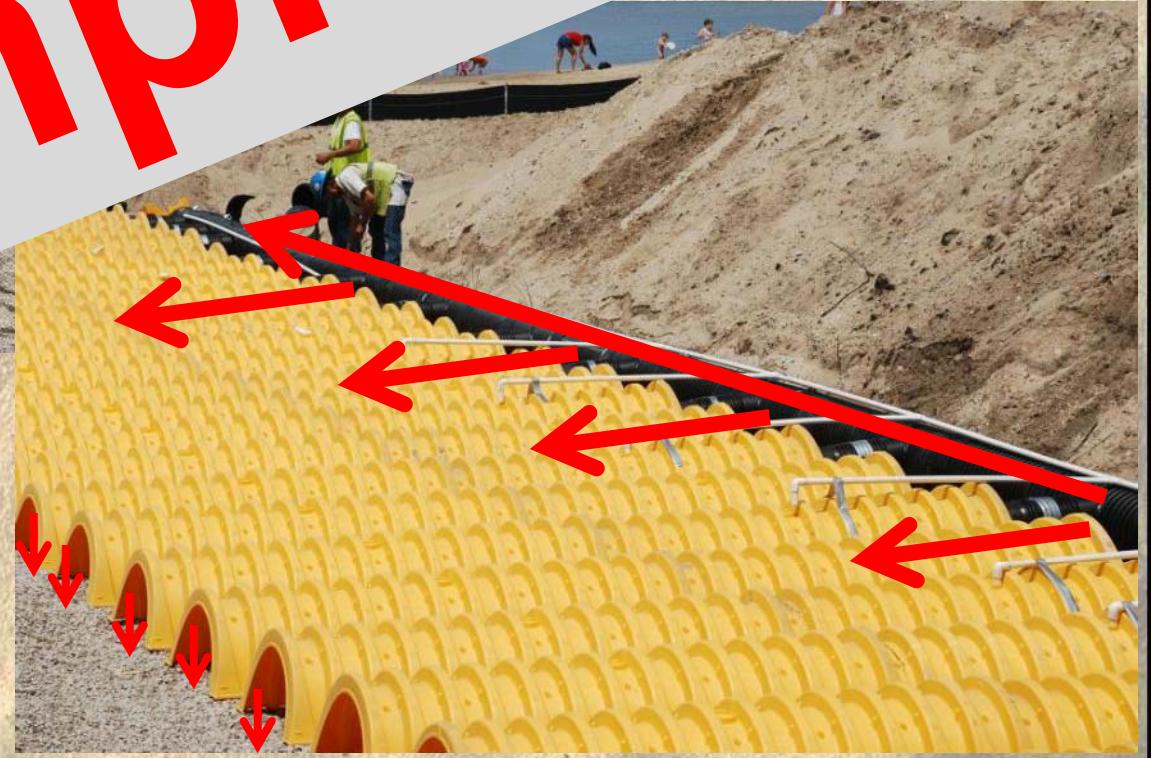
Right: Water will flow down the black pipe on the right (called the header tube) and then overflow into the yellow infiltration chambers to the left. The gravel will help the water filter naturally into the soil.

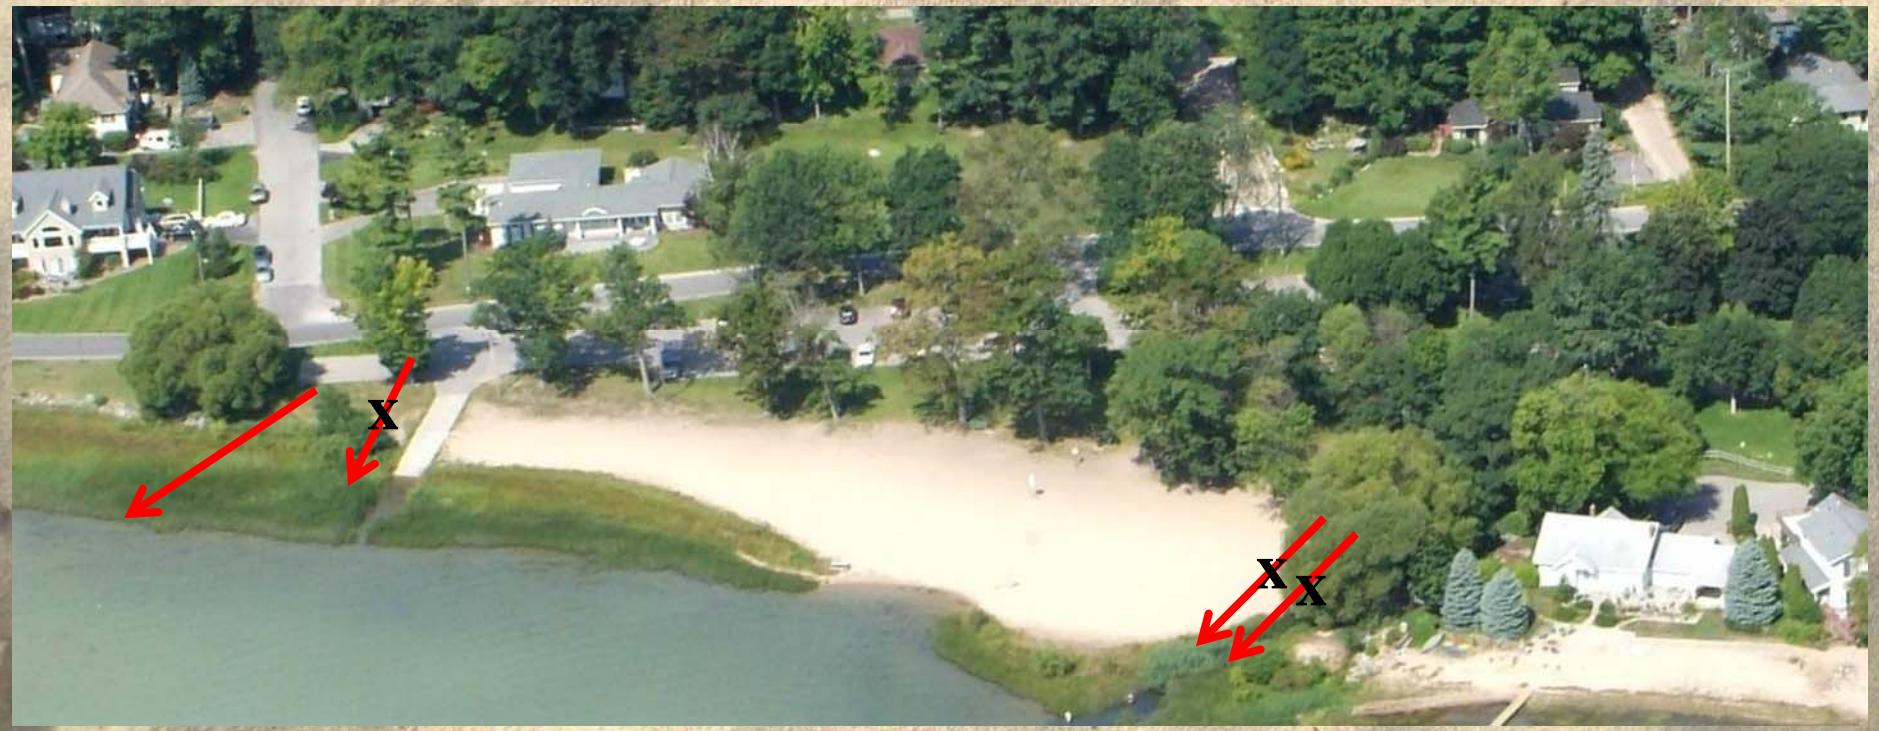
- No known illicit connections or obvious sources of human input (just raccoon poop)
- Poor infiltration and high groundwater table
- Reduce stormwater input to Bay
- Chosen BMP - end of pipe underground manufactured filter system
 - On three separate lines that outlet to Bay
 - Diversion weir and oil/grit/trash separators and filters (like Bryant Park Project)
 - Helix Cartridge Filtration System – high flow cartridge, treats pathogens, sediment hydrocarbons and nutrients
 - Combine drains, move to south edge of park away from swim area

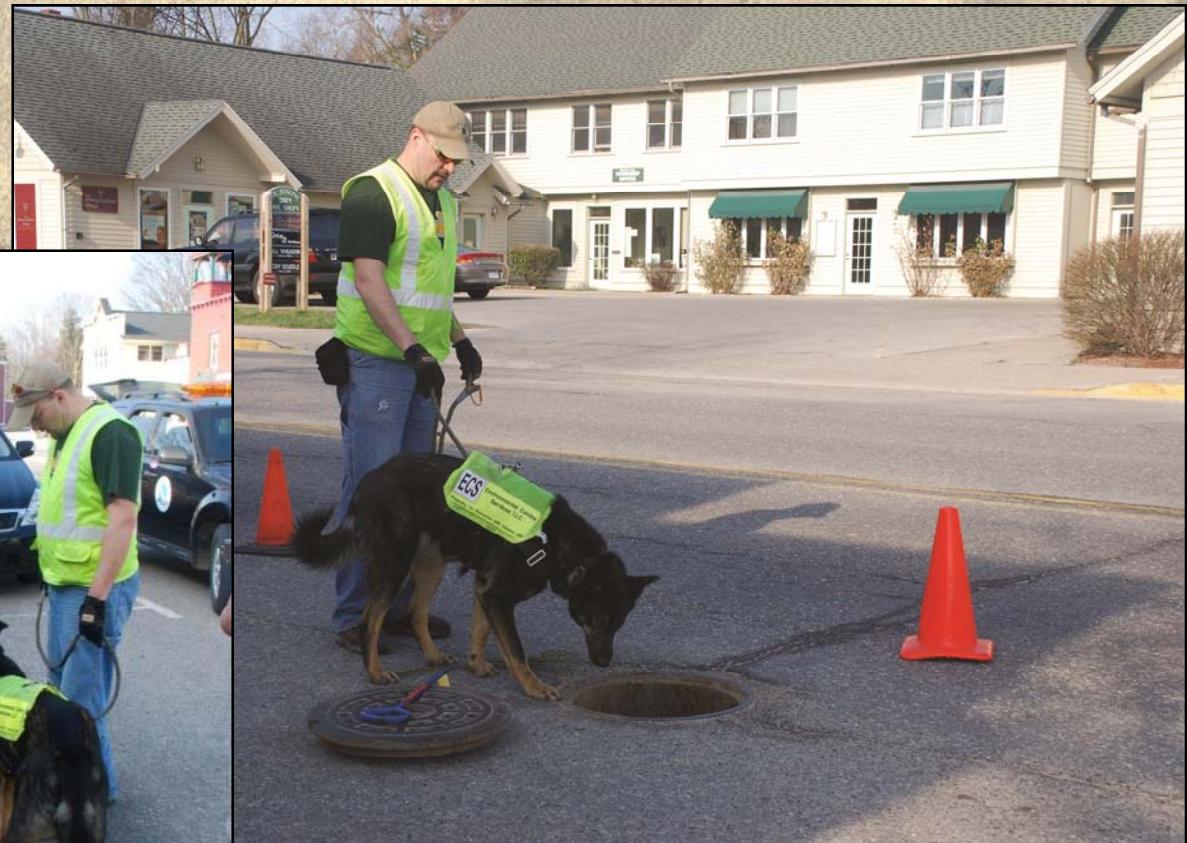
Scott and Sable inspect storm drains in Suttons Bay

- Took ONE DAY
- No 'hits' = no human sources of E.Coli
- Quickly verified E.Coli levels are animal sourced rather than human sourced
- Remediation project developed BMPs accordingly

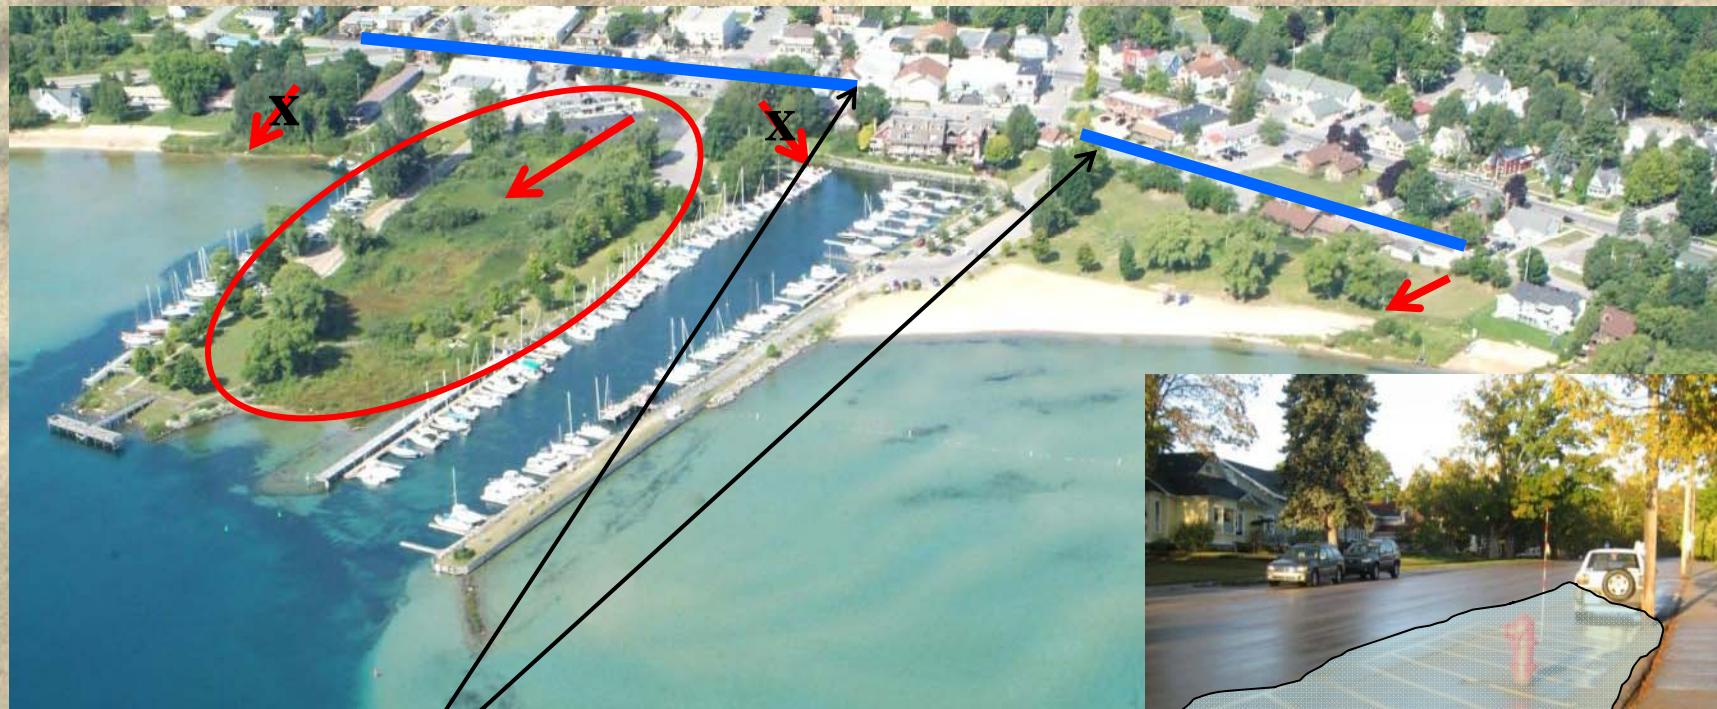
Above Blue Lines:
Infiltration trenches run
along length of Front
Street (parallel to Bay)

- Install series of BMPs to increase infiltration within Village and reduce amount of runoff making it to pipe outlets (rain gardens, underground infiltration trenches)
- Redirect two pipe outlets to wetland for additional treatment

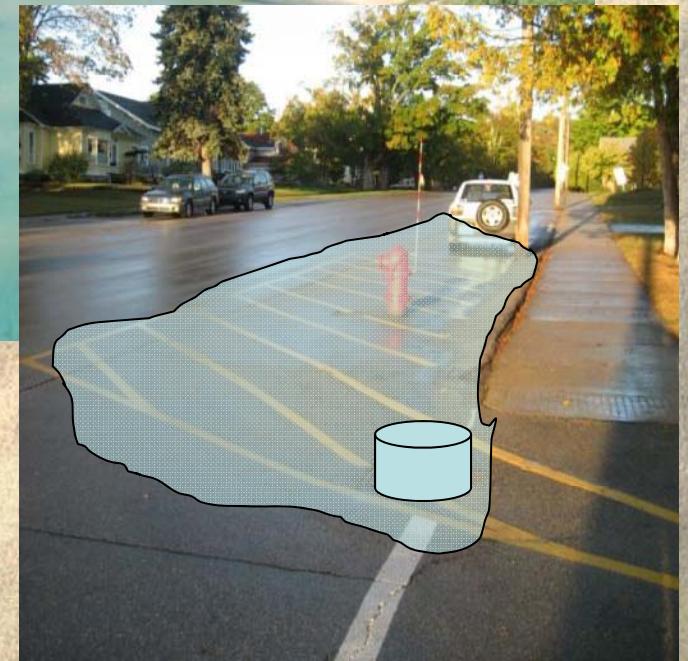
Right: Diagram of
proposed rain garden
site along road
